National Register of Historic Places Registration Form

Historic name Deerfield State Bank

Street & number 602 Main Street not for publication

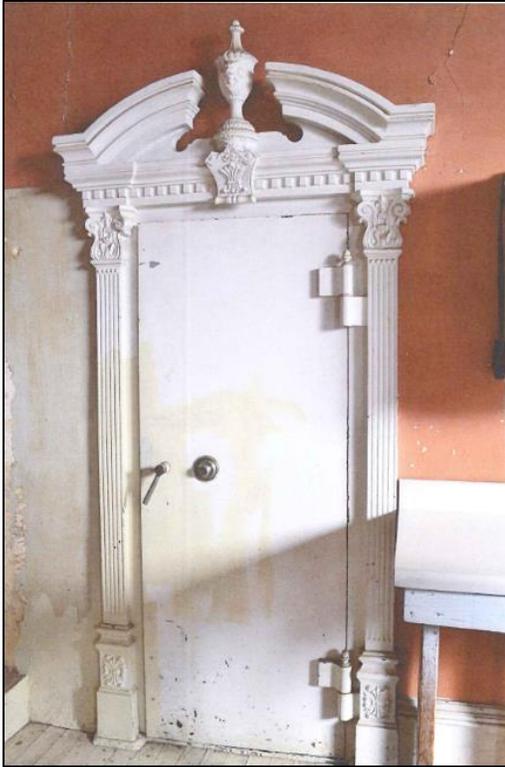
Figure 2: Vault door (Kala Lee Fortin).

The *main bank room* is accessed through the main entrance in the building's southwest wall (*Photos 4 through 6*). The room has high ceilings, which still include the original metal tiles. The room is also accessed through a door at the west end of the north wall that leads to a small foyer at the foot of the interior stair, accessed by the door in the west elevation (*Photos 6 & 8*). A door at the east end of the north wall leads into the space beneath the interior stair that was converted into a bathroom sometime after the building ceased to be used for a bank (*Photo 6*). On the north wall between the two doors is a slate chalk board; this slate was used by the post master, during the time that the building was a post office. At the north end of the east wall is the historic bank vault (*Figure 2*) (*Photo 4*). The vault has an arched ceiling and several historic vault inspection stamps from when it was Deerfield State Bank. A water heater was installed in this room at an unknown date. To the east still sits the original gas lantern that lit the inside of the vault.

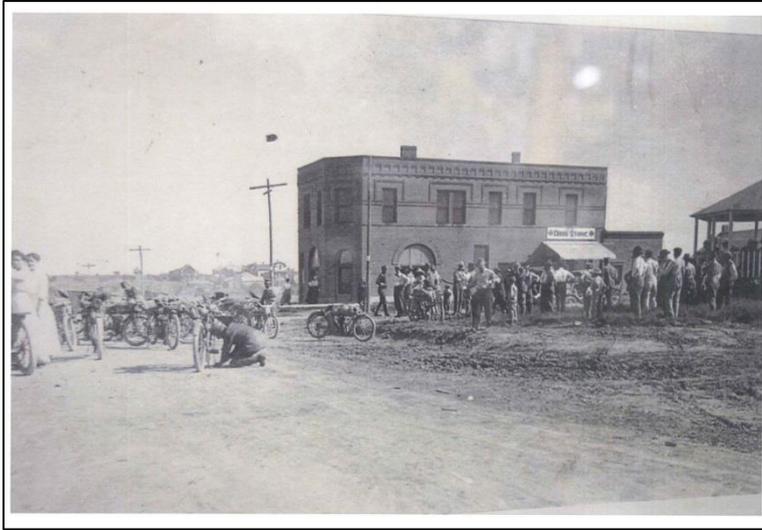
Figure 4: Deerfield State Bank building, unknown date. Drug store is located at the east end of the building (Kearny County Historical Society).

was officially closed. In 1946 though, the Kearny County Bank, in which the Deerfield State Bank merged, also merged with the Lakin State Bank a majority of it being bought by the Garden National Bank from local residents.²¹ Throughout this merging the Campbell family retained its spot as the bank's minority interest.²² After 1935, the Bacon Drug Store occupied a portion of the building (*Figure 4*).

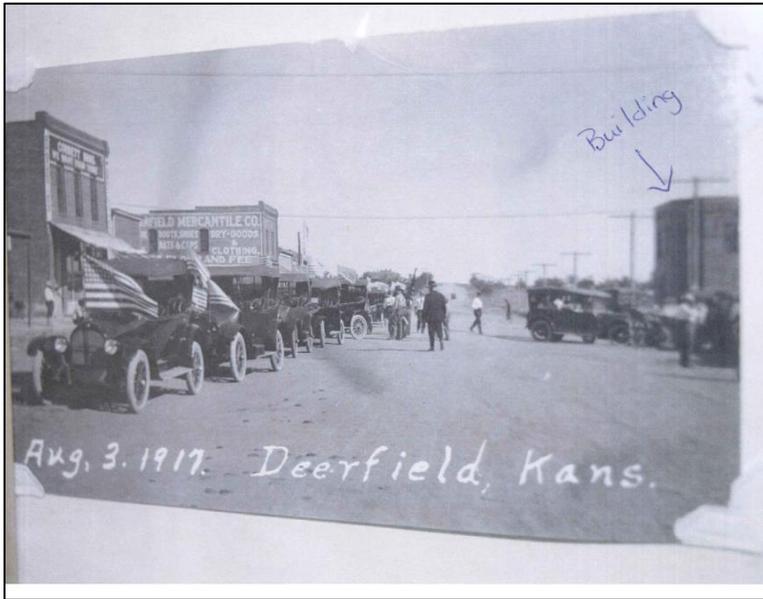
Figure 5: Deerfield, Kansas in 1917. View is looking north along Main Street (Kearny County Historical Society).

Although it is unknown exactly when the one-story structure was built to the east of the bank building, the building appears in historic images of the bank (*Figure 5*). Local tradition states this building housed Deerfield's first bar.
