National Register of Historic Places Registration Form

historic name Havana Stage Station

other names/site number 14OS1301; KHRI #139-0690-00002; NPS Master Plan #67

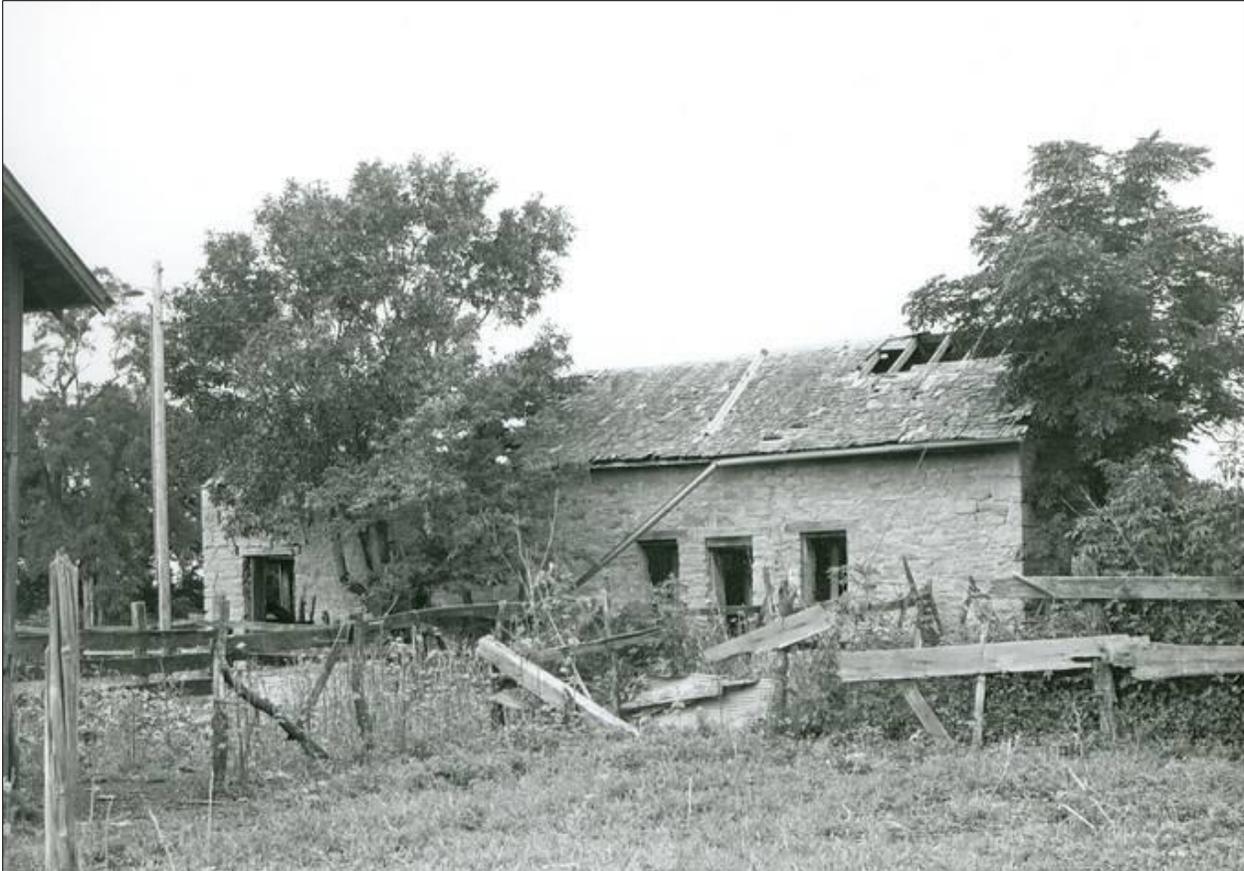
Figure 4.

The Havana Stage Station building as it appeared during a Kansas State Historical Society reconnaissance survey in 1971. View looking northeast.

Stage stations were most often complexes that consisted of several buildings and structures that created shelter for stock, the station keeper, and relay drivers; they also provided storage for forage and equipment.⁶ While it is known that a stage station was established at the short-lived town of Havana, the exact number of buildings and structures associated with the station is not known. This may be in part to the incorporation of structures into a working farmstead that was established sometime after the town of Havana was abandoned in 1869. While county atlases from 1879, 1899, and 1918 provide land owner information for those years, [REDACTED] Quadrangle map (produced in 1950) depicts three structures, which are likely the stage station building and two barns that may have post-dated the station (Figure 1). These three structures were still standing in 1971 when the Kansas State Historical Society conducted a brief reconnaissance at the site (Figures 4 & 5).

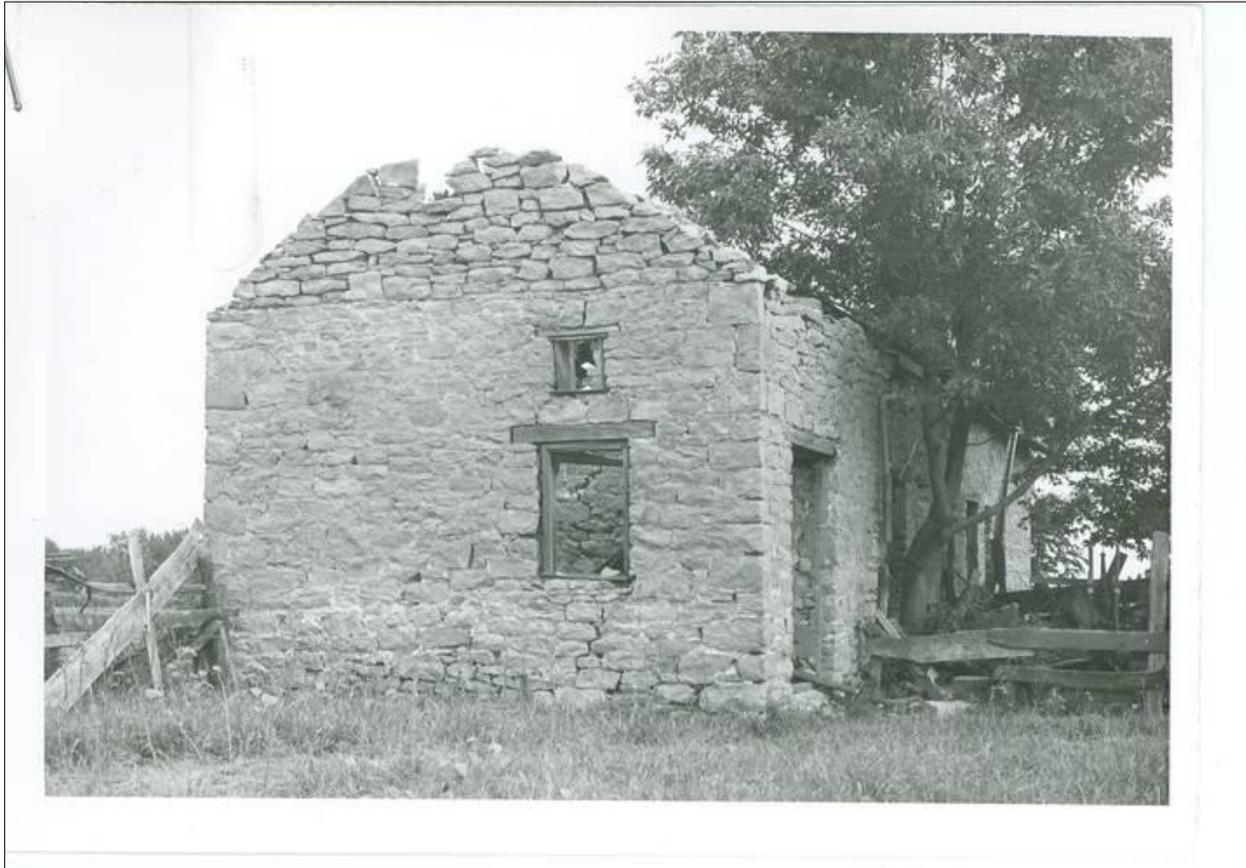
Figure 5.

The Havana Stage Station building as it appeared during a Kansas State Historical Society reconnaissance survey in 1971. South elevation, looking southeast.

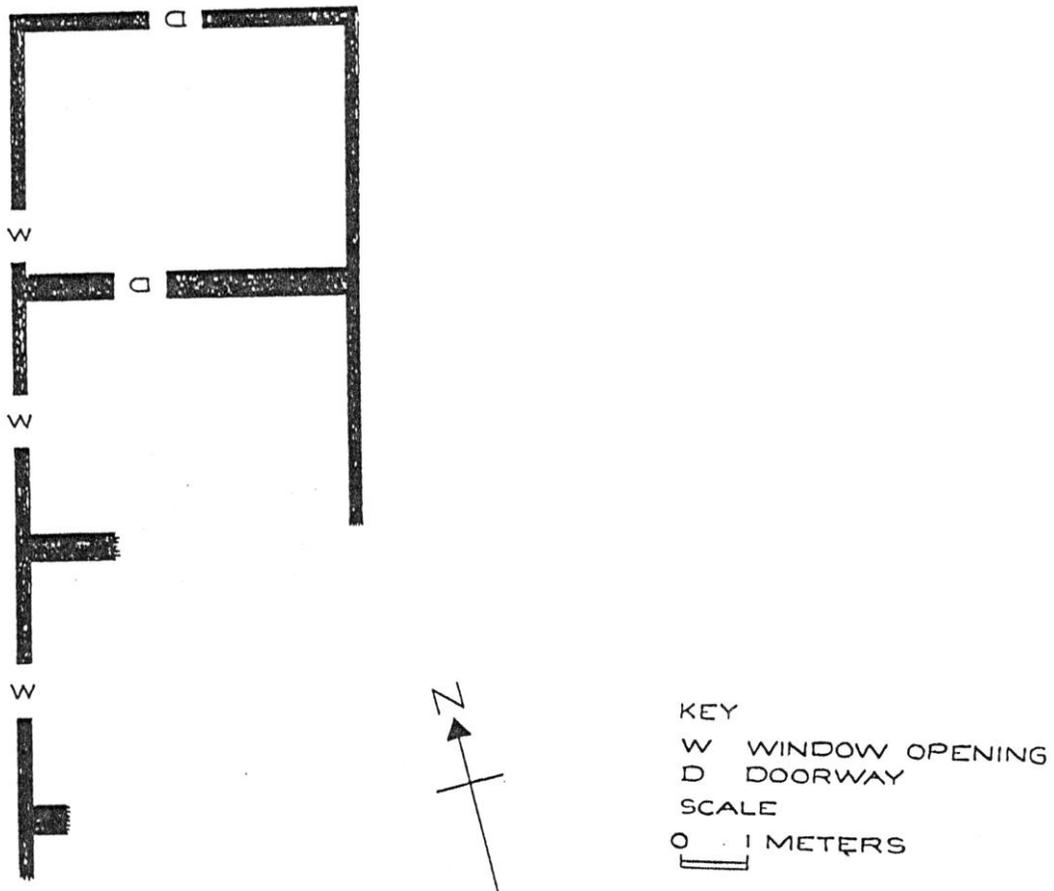
Figure 7.

Sketch plan of the ruins, as mapped by The URBANA Group in 1993.
The "D" on the north wall was actually a window, and it was not centered in the elevation.
The image was drawn with the west wall as the east wall; it has been mirrored here to show its correct orientation.

In 1993, a nomination to the National Register of Historic Places was drafted by The URBANA Group.⁷ As part of that process, a map of the property and its standing structures was prepared. This map shows several structures (and remains of structures) [REDACTED]. The remains of the existing stage station building (marked as ruins) were present at the site's northern end, as were the two barns observed in 1971 along with a rubble mound (marked as ruins). In addition, stone and barbed wire fences were present, along with a depression and a capped domestic well (Figure 6). The surveyors also prepared a plan of the extant building ruins (Figure 7).

Photographs and drawings reconstruct the appearance of this building. The north wall was gable-ended. On the west side of the north elevation was a window opening large enough for a double-hung sash. Centered above this window was a small square window opening. The east wall shows no evidence of ever having openings. The south wall was not documented photographically and was fallen by 1993 when the plans were made; openings on this elevation are unknown. Though the west wall is no longer extant, photographs indicate it contained seven openings (one in the form of a small window at the eave). Two openings were doorways; three openings were still discernible in 1993. All openings appear to have had wooden lintels. Field investigations indicate that this station building contained three or four rooms; the northernmost room still had remains of all four walls in 1993, and portions of the cross walls remained during a reconnaissance survey in 2012.

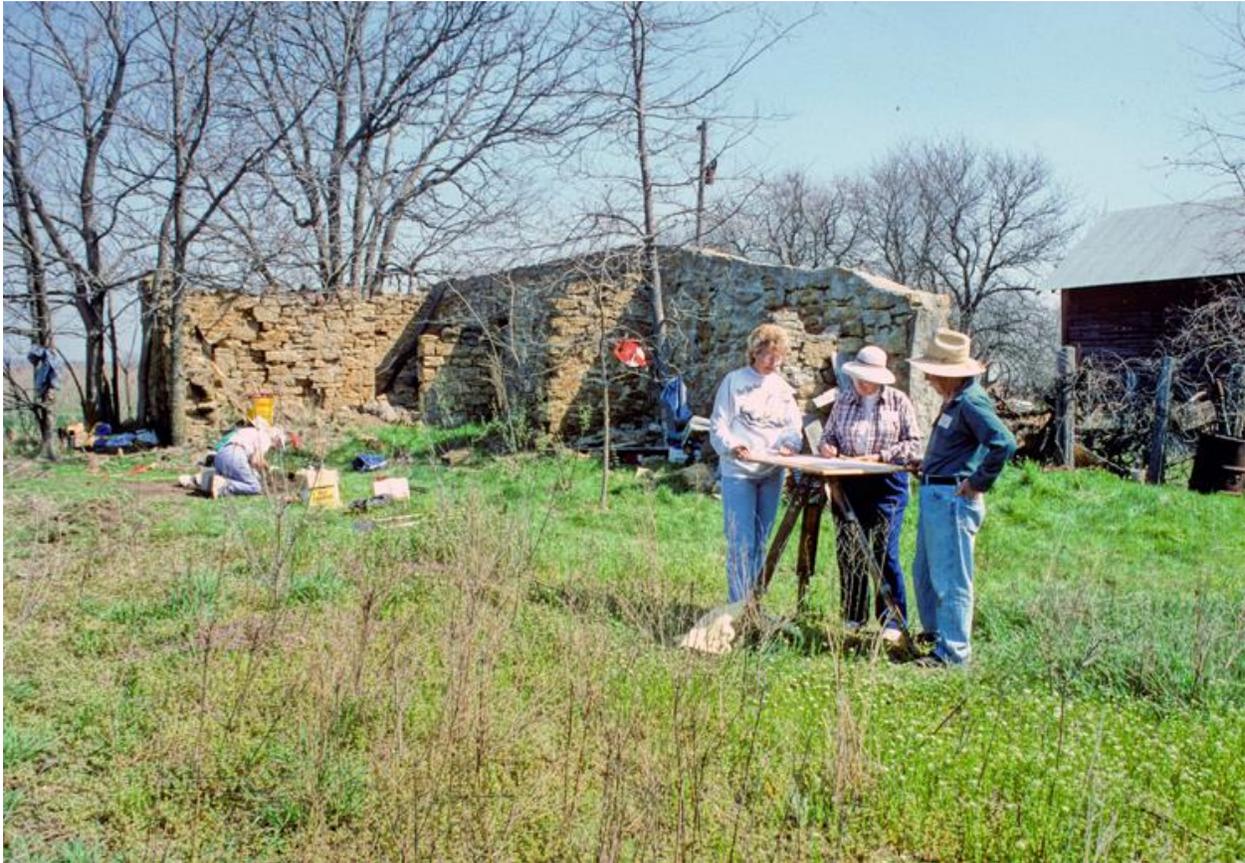
Figure 9.

Kansas State Historical Society excavations underway at the Havana Stage Station in 1995.

In 1995, the site was chosen for archeological test excavations as part of the Kansas Archaeology Training Program (KATP). By then, only the ruins and one of the barns were still standing, along with the other features noted in 1993 (Figure 8). During several days of work, four test units were excavated, measured drawings of the ruins were prepared, and a metal detector survey was conducted (Figures 8 through 10). One test unit was placed along the west side of the stage station building ruins, while a second was placed near the rubble mound to the south. A third unit investigated the small depression, and the fourth was placed so as excavate a possible cellar wall. The excavations resulted in recovery of a large quantity of artifacts, including machine-cut square nails, farm machinery parts, and fragments of barbed wire. The metal detector survey recovered a brass finial, a padlock, and a metal step, possibly from a stage or buggy. In addition, intact subsurface structural remains, some dating to the trail period, were recovered.⁸

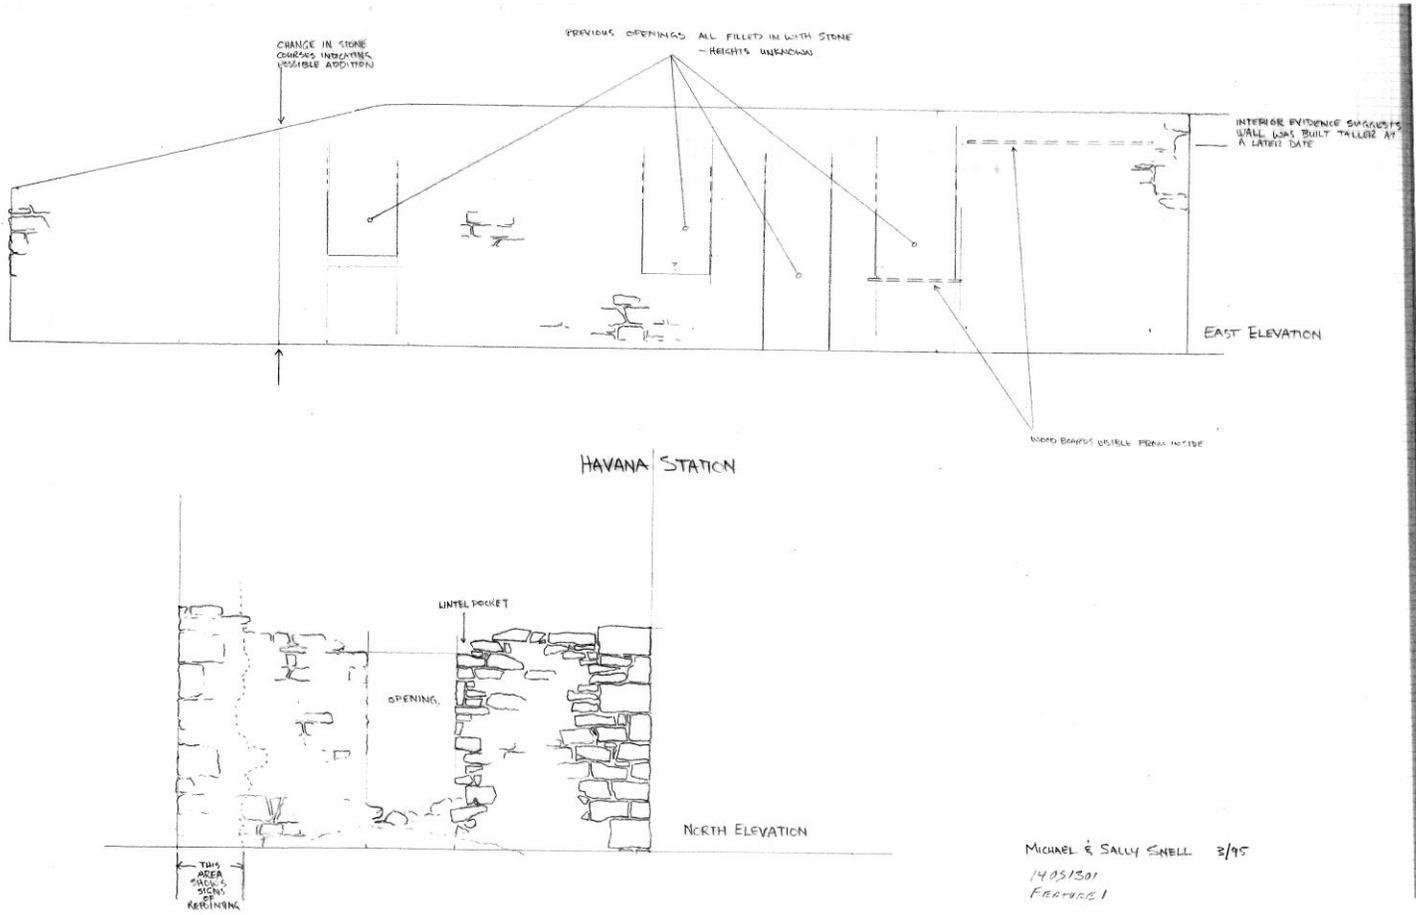
Figure 10.

Measured architectural drawing of the Havana Stage Station, produced during the Kansas Historical Society investigations in 1995.

The rectangular, gabled building has native limestone foundation and walls and measures 5 meters (16 feet) east-west by 12.75 meters (41 feet) north-south. The extant standing walls are approximately 1.8 meters (6 feet) in height at the highest, though they may have been as high as 3.65 meters (12 feet) or more when built. Only portions of the north wall and 7.75 meters (25 feet) of the west wall remain.

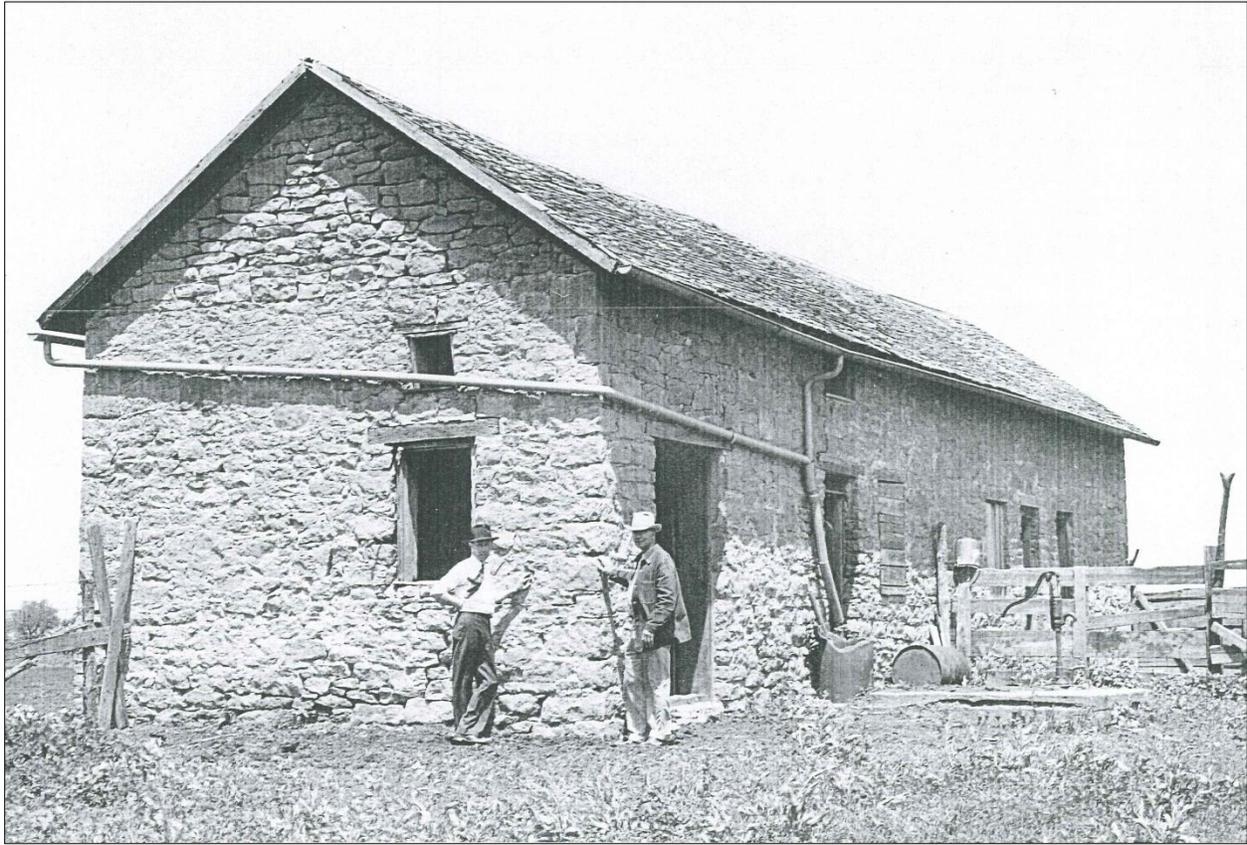
Figure 11.

1966 photograph of the Havana Stage Station.
Looking northwest at the south and east elevations with Harold Stodard (with tie), publisher of Enterprise-
Chronicle and Gene Spaulding, rancher and stockman.
Kansas State Historical Society: Photograph Collection. Osage County – Historic Buildings. FK2.01 .79.

photographs or written descriptions of the station have been uncovered, so a complete description of the use and historic appearance is not possible at this time. However, the relative closeness of the Havana Stage Station (both geographically and temporally) to the McGee-Harris Stage Station at 110 Mile Creek [REDACTED] may imply similar building styles. Further, modern-day photographs and archeological surveys provide clues to this structure's appearance. The earliest known photograph of this building is from 1966 (Figure 11).
