Register of Historic Kansas Places Registration Form

Historic name Marion County Poor Farm
Other names/site number Marion County Asylum for the Poor, Cedar Villa, Cedar Rest, KHRI #115-0000-00826
Name of related Multiple Property Listing N/A

street & number 1625 Old Mill Rd not for publication
city or town Marion vicinity
state Kansas code KS county Marion code 115 zip code 66861

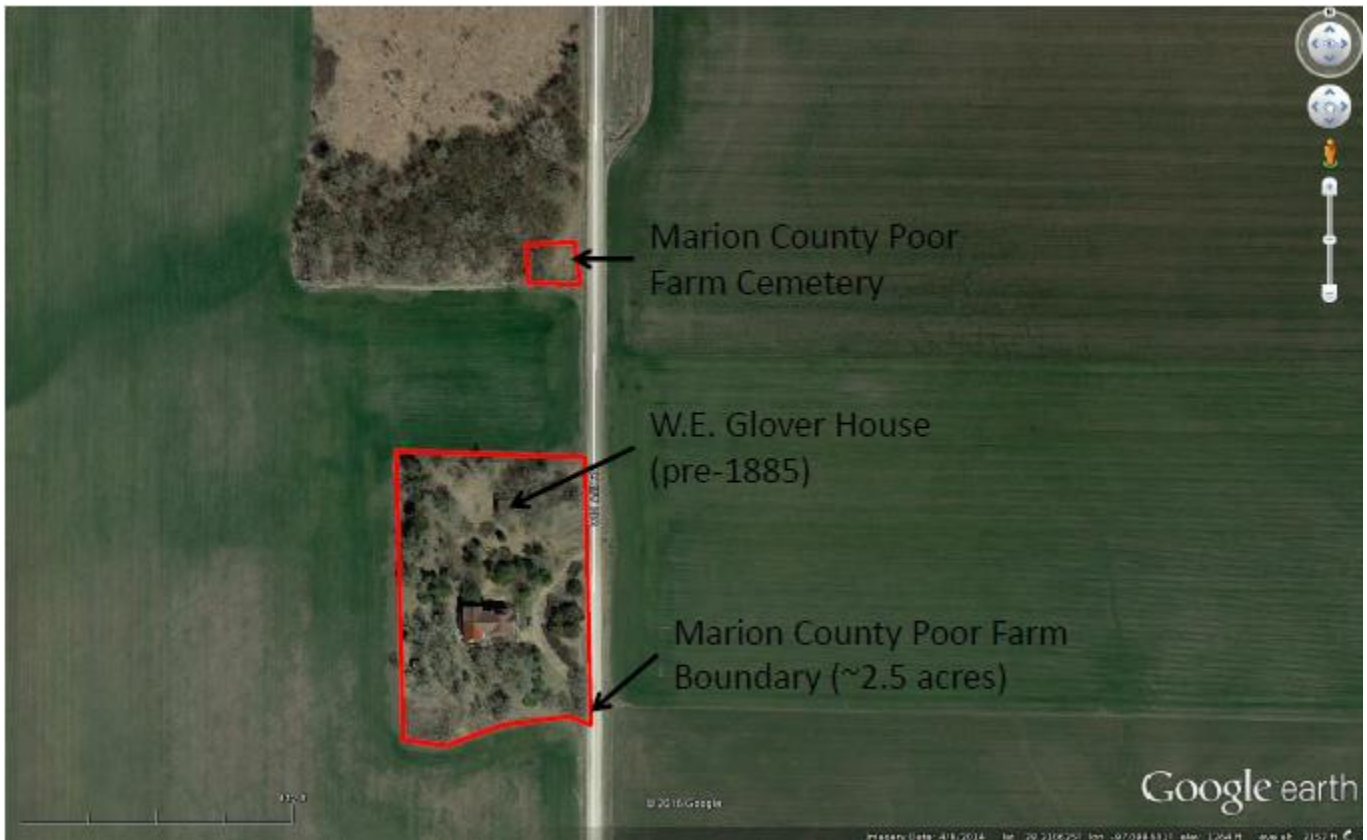
Figure 2: Locational map, showing boundary of poor farm in relation to cemetery.

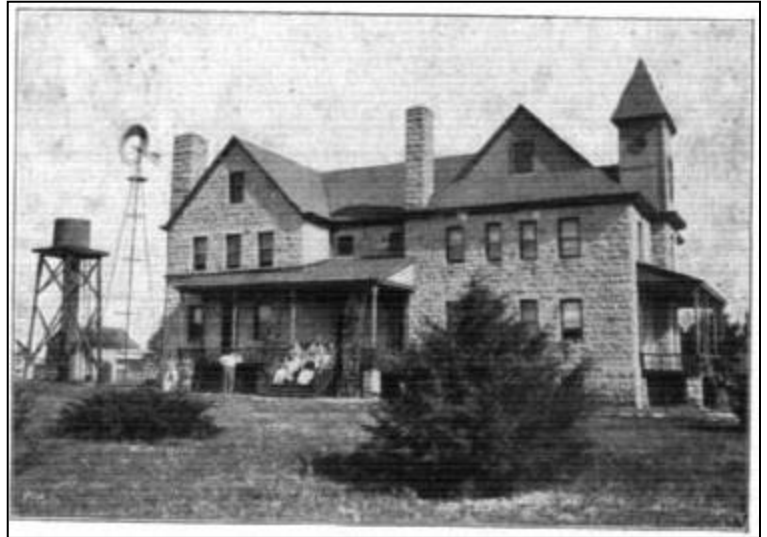
Figure 4: Marion County Poor Farm 1901 (1902 county atlas)

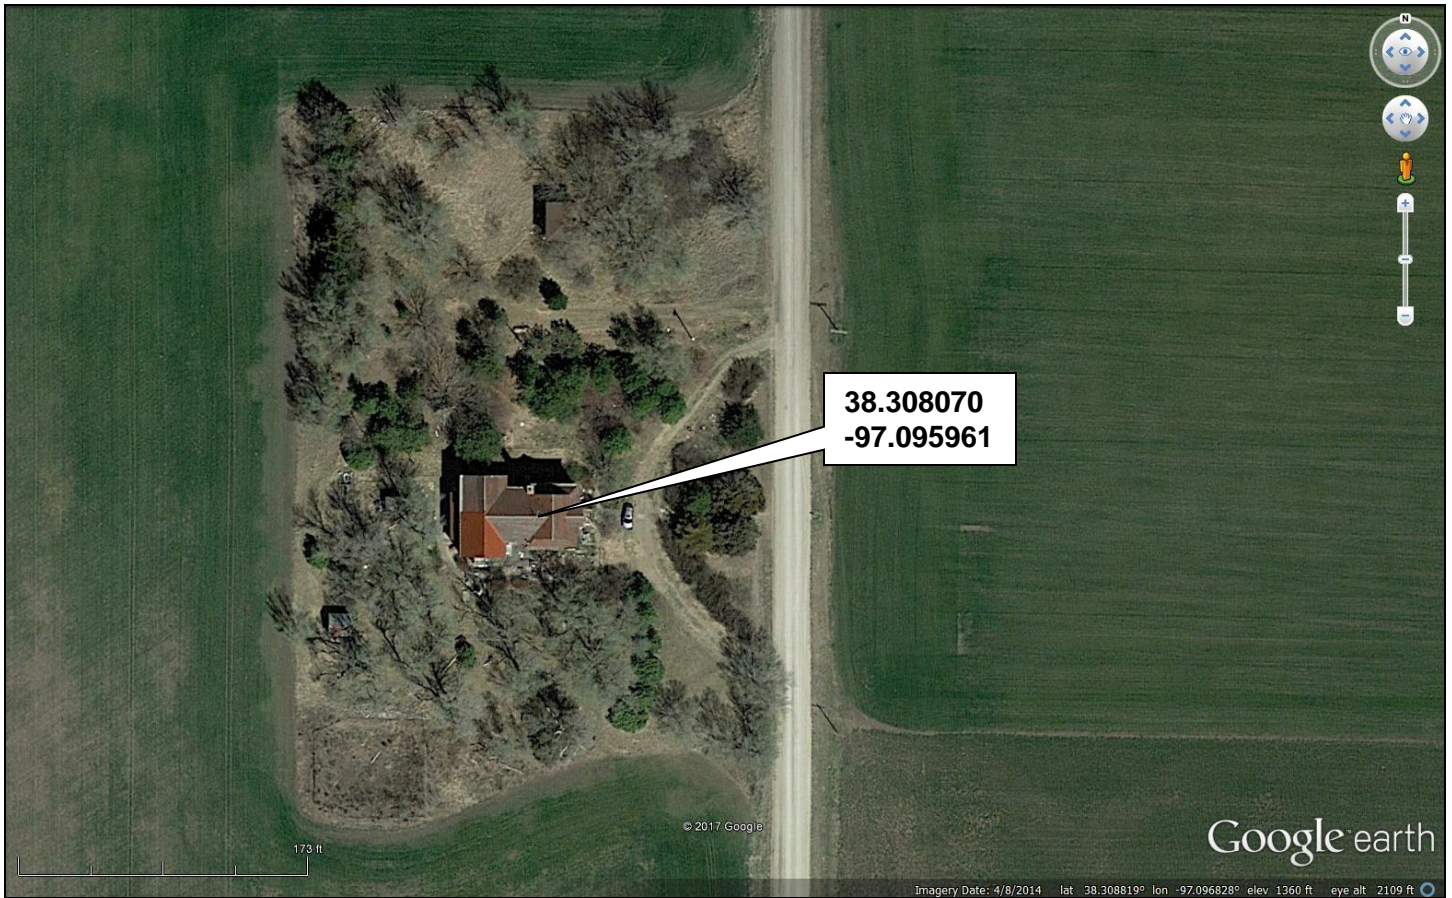
Boundary Map.

The nominated boundary is a rectangular parcel bounded on the south, west, and north by property lines separating the property from agricultural fields and on the east by Old Mill Road. The parcel in S16, T20, R3 is described as follows: PRT E/2 SE/4 BEG 1065' N SE/C SE/4 N 436' W 300' S 436' E 300' TO POB LESS ROW.
