National Register of Historic Places Registration Form

historic name Bierer, Samuel, House
other names/site number 013-2450-00043

street & number 410 North 7th Street not for publication
city or town Hiawatha vicinity
state Kansas code KS county Brown code 013 zip code 66434

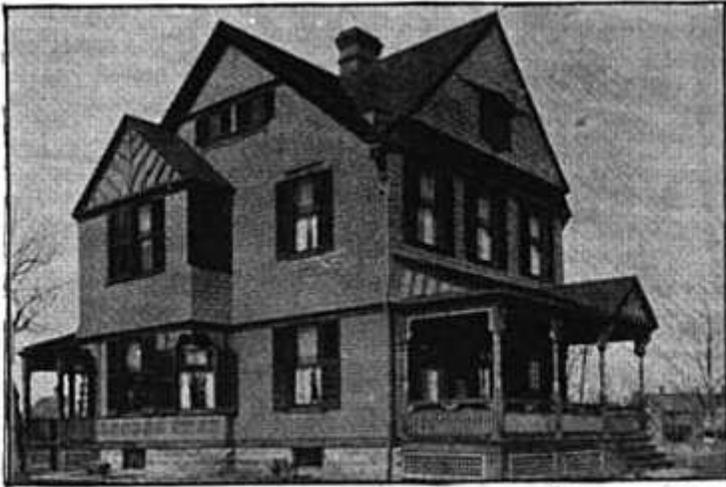
Figure 3: Historic Image of Samuel Bierer House, circa 1900. Source: Harrington, Grant. *Annals of Brown County, Kansas*. Hiawatha, KS: Harrington Printing Co., 1903.

RESIDENCE OF SAMUEL BIERER

The simplest and most common way to update the exterior of a fashionable residence during this time was to change the porches, which the Bierers did. Other known changes they made included extending the roofline to create broader, sweeping eaves and converting the gabled bay on the south elevation to a sweeping shed roof.¹⁷ The front porch was enlarged to wrap around to the north (side) elevation and its shed roof with intersecting gable above the steps was replaced with an enlarged, low-pitch hipped roof. It now features grouped upper columns that rest on massive limestone porch piers. Specifically, the two corner piers support groups of three short, square, wood columns, and the center pier supports two columns.
