National Register of Historic Places Registration Form

Historic name Abernathy Furniture Company Factory (Boundary Increase, Discontiguous District)

Other names/site number Plant K; KHRI #103-3020-00066, 103-712 through 103-714

Street & number 1100 N 2nd St. not for publication

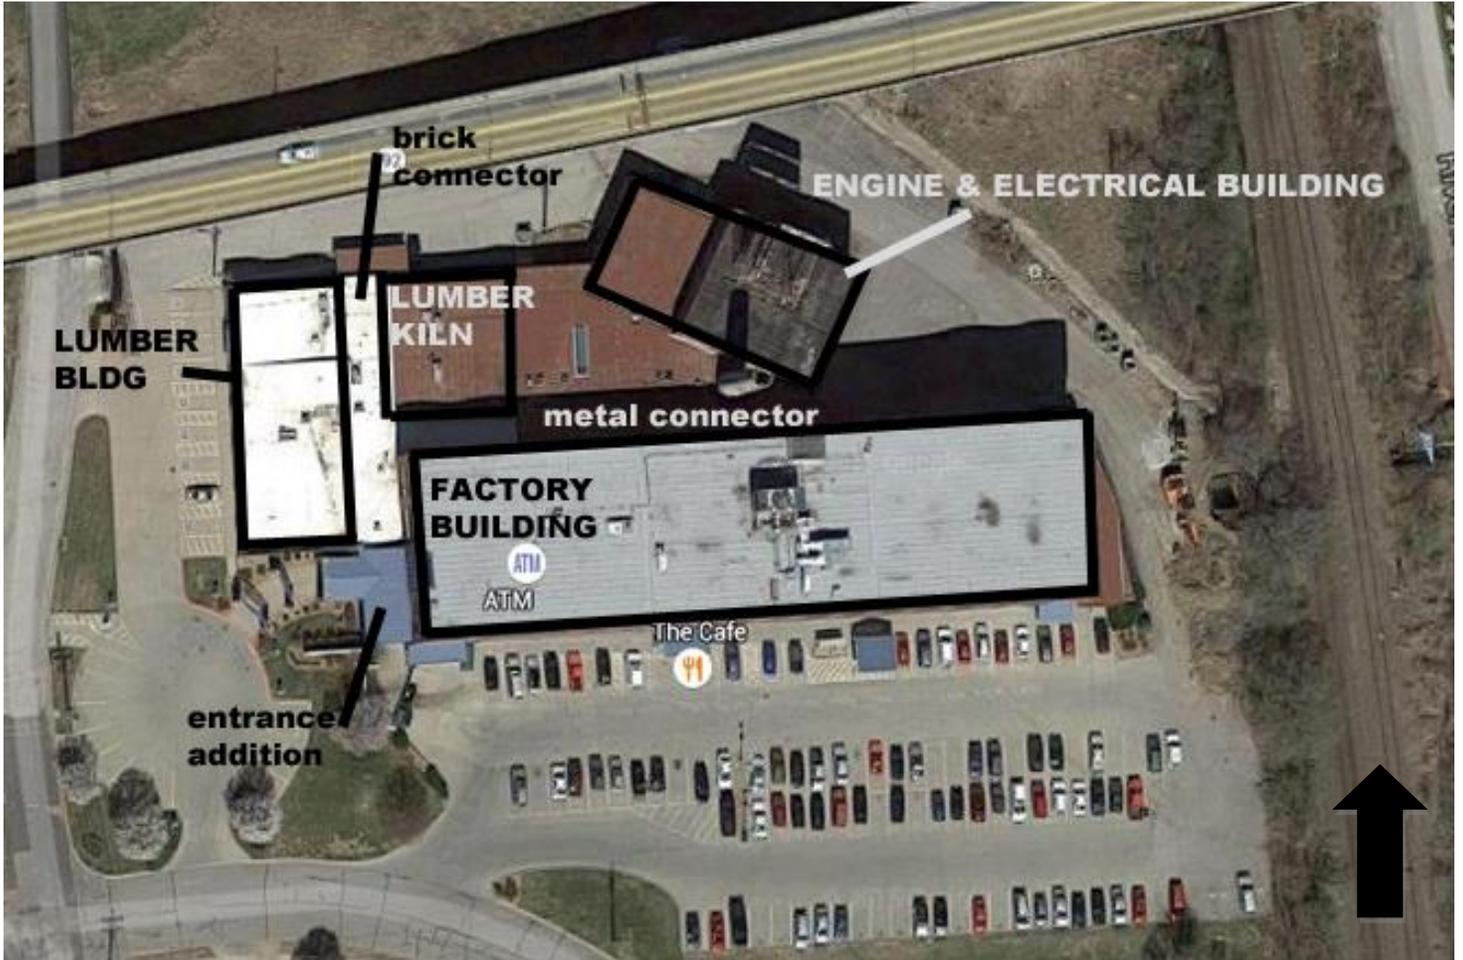
Figure 3: Plant K Resources Map. Source: Google Maps 2015.

Seven buildings comprise Plant K (*Figure 3*). The large rectangular Factory Building runs east west at the center of the property. The rectangular Engine & Electrical Building extends northwest-southeast along the center of the north side of the Factory Building (*Figure 1*). A large smokestack rises between the two buildings. The square Lumber Kiln building is located at the west end of the north side of the Factory Building. The west elevations of these two buildings historically aligned. The rectangular Lumber Building runs north-south and abuts the northwest corner of the Factory Building. Non-historic additions connect all the buildings. Between the Factory Building, Engine & Electrical Building, and Lumber Kiln, impermanent one-story corrugated metal walls connect the buildings. A more permanent one-story brick addition connects the Lumber Kiln and Lumber Building. A glazed entry vestibule connects the Lumber Building and the Factory Building.
